Failure Analysis of Cracking in a Diesel Engine Aluminum Alloy Cylinder Head

Dongfeng Automobile Co., Ltd. (DFAC), Wuhan 430000, China

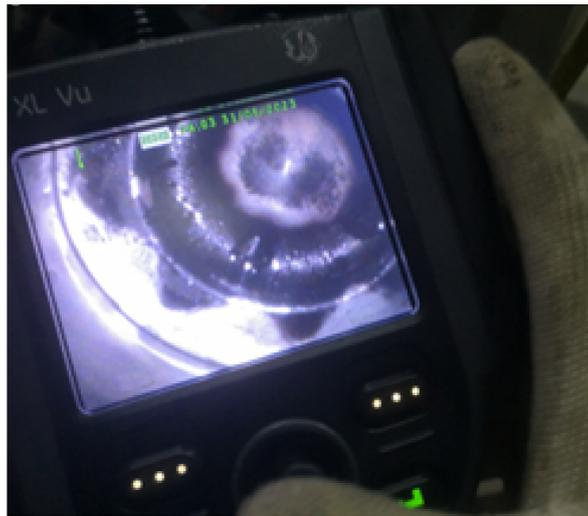
During a thermal shock durability test, an aluminum alloy cylinder head of a diesel engine exhibited abnormalities in the durability test after running for 260 h. The coolant in the expansion tank was significantly reduced. Upon checking the engine test operation data, no abnormalities were found in the power, torque, exhaust temperature, inlet and outlet water temperatures, and inlet and outlet water pressures. After shutting down, an endoscope was used to inspect the cylinder, revealing a small amount of liquid in the combustion chamber of the fourth cylinder, as shown in Figure 1. No abnormalities were found in the other three cylinders.

Figure 1. Liquid in the combustion chamber.

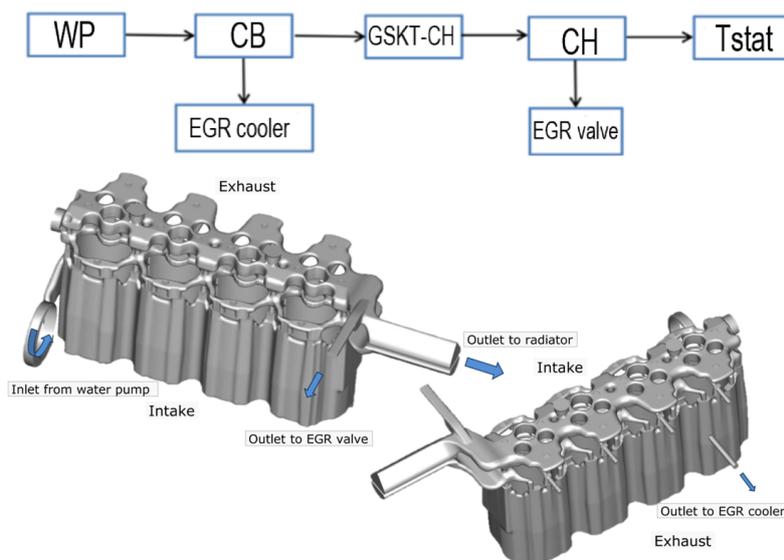
Based on the schematic diagram of the engine cooling system and the flow direction of the engine coolant, the coolant enters the cylinder block cooling water jacket through the water pump, passes through the cylinder gasket into the cylinder head cooling water jacket, and then flows out from the thermostat. The EGR cooler draws water from the cylinder block, while the EGR valve draws water from the cylinder head, as shown in Figure 2. The possible paths for coolant entering the combustion chamber are analyzed as follows: (1) Internal water-gas intercommunication in the EGR cooler; (2) Internal water-gas intercommunication in the EGR valve; (3) Seal failure of the GSKT-CH; (4) Internal cracking of the cylinder head; (5) Deformation of the combustion chamber surface of the cylinder block or cylinder head, etc.

Figure 2. Paths for Coolant Entering.

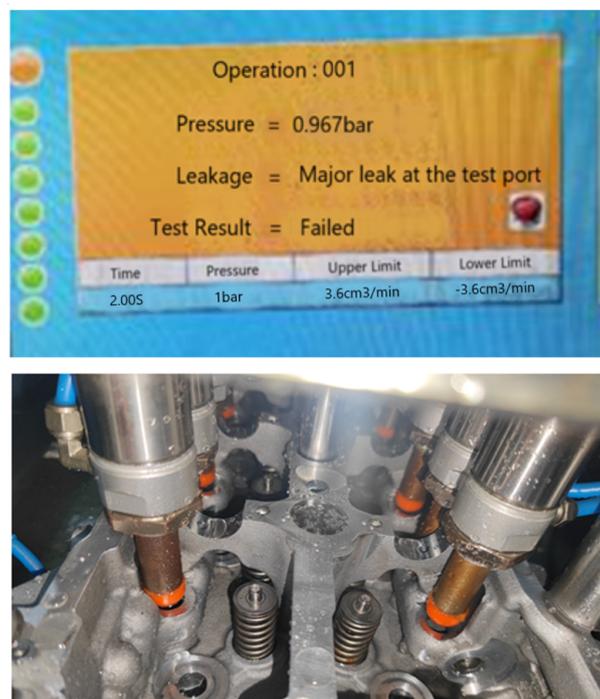
Step 4: A dial gauge was used for preliminary testing of the flatness of the combustion chamber surfaces of the cylinder block and cylinder head. The measurement results showed that the flatness of both the cylinder block and cylinder head was within 0.03, initially indicating that the combustion chamber surface of the cylinder head had not deformed. Subsequently, sealing tests were conducted on the water jackets of the cylinder block and cylinder head. The cylinder block passed the sealing test, but the pressure for the cylinder head water jacket sealing test could not be established, as shown in Figure 3, indicating that a crack had developed inside the cylinder head, which was identified as the main cause of the engine's water and gas mixing.

Figure 3. Sealing Test.

A sealing test was conducted on the water jacket of the cylinder head, sealing the combustion chamber surface and the outlet hole of the thermostat. Air was introduced through the water inlet hole of the EGR valve, with a pressure of 1 bar. According to the standard testing method, it was found that the pressure of 1 bar could not be established, indicating a significant leak. A water test was performed to locate the leak

points, and the results showed that numerous bubbles were emerging from the injector holes of cylinders 1 to 4. Specifically, see Figure 2. It is inferred that there are cracks at the injector holes of the cylinder head [4–6].

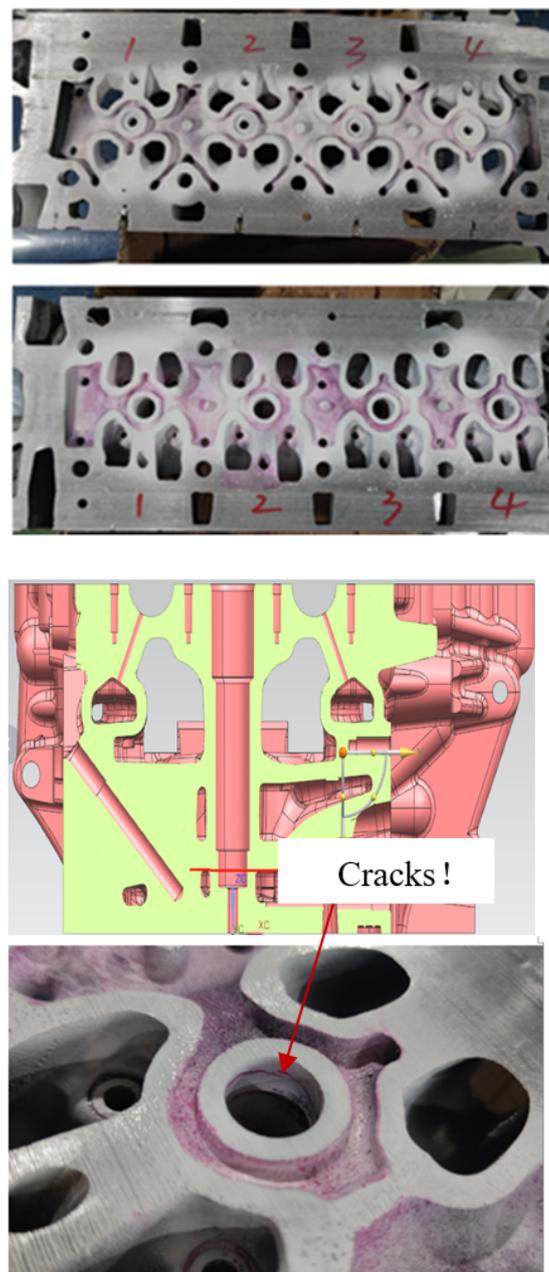
Based on the structure of the water jacket of the cylinder head, a cross-section was taken 20 mm from the combustion chamber surface, followed by a visual inspection. Cracks were found at the top surface of the water jacket below the injector holes, with cracking occurring at the injector holes of all four cylinders. The specific locations of the cracks are shown in Figure 4.

Figure 4. Locations of the Cracks.

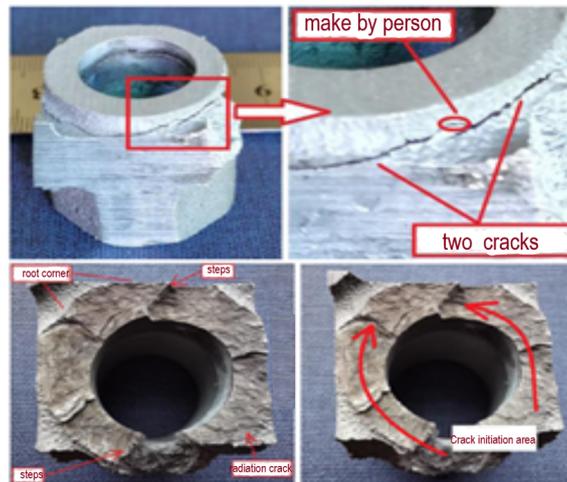
The cracked area of the failed cylinder head is not completely separated. A grinding wheel was used to cut the failed cylinder head, exposing the crack at the injector hole of cylinder 4 for sampling. A macroscopic examination of the fracture surface was conducted using the large end of the sample block for analysis, and the fracture surface is shown in Figure 6. The results of the macroscopic examination are as follows:

- (1) The fracture surface exhibits a black oxidized color, indicating a brittle fracture;
- (2) There are five steps on the fracture surface, with the step fractures being silver-white and unoxidized. The five steps divide the fracture surface into five regions along the circumferential direction. This feature indicates that each region of the entire fracture is formed by the expansion of independent crack sources;

- (3) Each region has distinct radial striations, all pointing towards the outer edge of the fracture (i.e., the rounded root), indicating that the rounded root of the outer edge of the fracture is the source of the fracture cracks;

- (4) The distribution and orientation characteristics of the cracks are as follows: this structure is subjected to alternating torsional loads. When the two halves of the fracture are combined, two independent cracks are interwoven. The cracks in the entire fracture are arranged in two directions, with three cracks having a right-handed twist and two cracks also having a right-handed twist, but with a very small helical angle. The ends of the cracks in each region are below the step root. Based on these features, a preliminary judgment can be made regarding the crack orientation in each region and the initiation and propagation direction of the entire fracture [10,11].

Figure 6. Fracture (Crack) Surface.

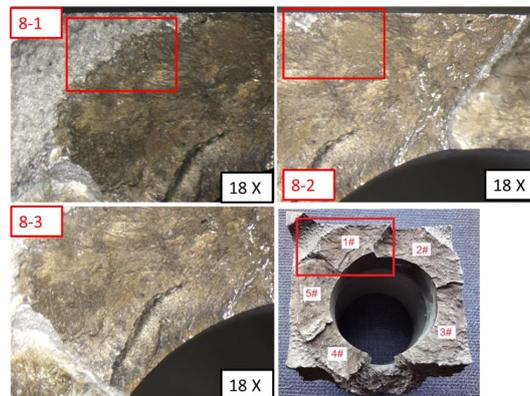
Optical microscopic examination and scanning electron microscopy analysis were performed on five regions labeled 1#–5# on the fracture surface. A macroscopic examination of the fracture region 1# was conducted using an optical microscope, and the examination area is shown in Figure 7.

A significant number of pores and micro-void defects were found in the corresponding area.

Figure 7. Examination Area.

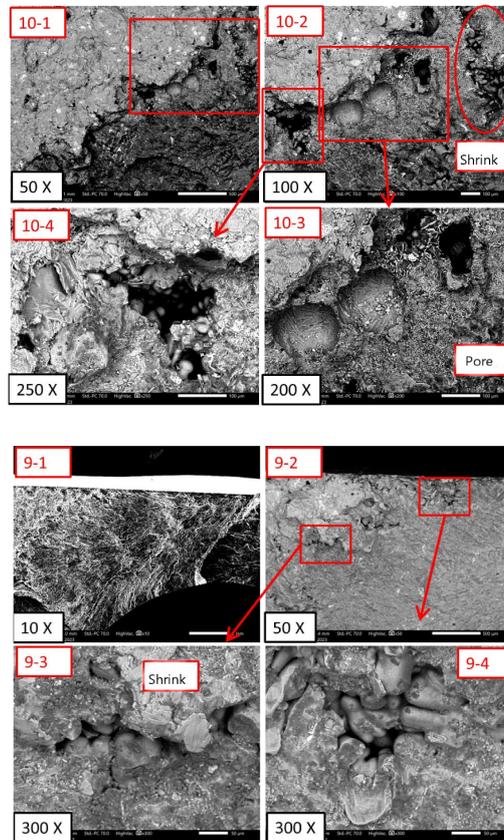
For the areas marked 8-1 and 8-2 in Figure 7 of Region 1#, electron microscopy scans were conducted, revealing a considerable number of pores and micro-void defects, as shown in the following Figure 8. The area marked 8-1 corresponds to 10-1/2/3/4 in Figure 8, while 8-2 corresponds to 9-1/2/3/4 in Figure 8.

Figure 8. Electron Microscopy Scanning Photos of Fracture Region 1#.

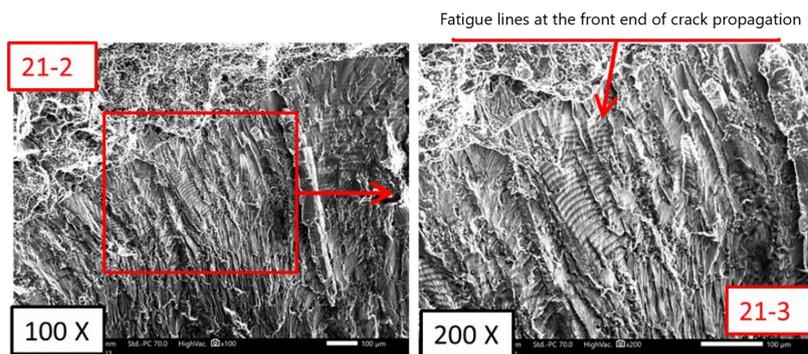
After embedding, grinding, polishing, and etching the fracture surface (with a 20% dilute nitric acid solution), electron microscopy scans were performed to further examine the cross-sectional casting defects and microstructural defects. The results indicated the presence of hydrogen pores on the surface and inside the casting. Through electron microscopy scanning, seven pores and twelve micro-voids were distributed along a 5 mm length interface at the junction of the crack surface and the casting surface. These micro-pores and micro-voids measured approximately 0.1–0.4 mm. In the examination of four other areas, a significant number of pores and micro-void defects were also found. Scanning the micro-pores or micro-voids on the fracture surface of the casting revealed that the size of the surface pores or micro-voids could reach up to 0.2 mm. In the examination of Region 5, micro-void defects were found at the crack boundary. The electron microscopy scan at the crack tip indicated the presence of fatigue striations and a large number of river patterns (cleavage steps), with the river patterns being perpendicular to the fatigue striations and pointing in the direction of crack propagation. As shown in Figure 9, this type of fracture indicates that the crack is a

result of brittle fatigue fracture, with the source of the crack defect originating from casting defects on the surface of the casting.

Figure 9. Scanning Electron Microscope (SEM) Images of Fracture in Area 5#.

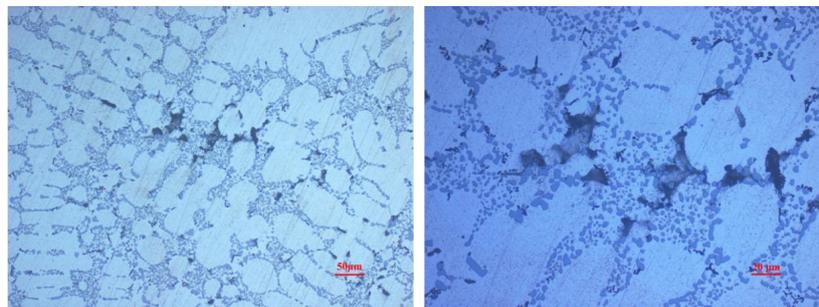
The SEM energy spectrum analysis indicates that the microstructure of the casting consists of a solid solution and eutectic structure, with a small amount of iron-rich phase distributed at the grain boundaries. As shown in Figure 10, the metallographic structure includes: α (Al) dendrites + short rod-like or granular eutectic silicon + a small amount of blocky primary silicon. The microstructure is normal without signs of overheating or overburning.

Figure 10. Metallographic Structure ($\times 200$ and $\times 500$).

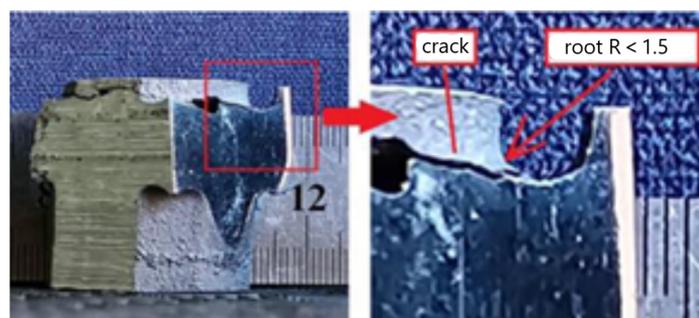
- (1) Location and Distribution of Cracks at the Injector Hole. Cracks at the injector hole are located at the rounded corner rather than at the thinnest section, indicating that there is stress concentration at the rounded corner, which measures approximately 1.5 mm, as shown in Figure 11. Additionally, cracks in the water jacket were found on the intake side near the fire surface of cylinder 4. The water jacket cracks are much finer than those at the injector hole, and no water jacket cracks were present until the cracks at the injector hole had fully developed. It is possible that the cracks at the injector hole fully developed before the water jacket cracks began to form and propagate.

Figure 11. Rounded Corners of Cracked Areas.

- (2) The microstructure is relatively coarse (especially near the cracks).
- (3) Additionally, there may be structural factors in the casting that promote cracking, such as small radii at the fracture site, which lead to greater stress concentration (including thermal and mechanical stress).

- (1) Control the core-making process during the casting production, especially controlling the gas generation from the sand core and the moisture content of the sand core. This will reduce the reaction between water vapor in the sand core and the molten metal, thereby decreasing the hydrogen content in the aluminum melt.
- (2) Strengthen the degassing and refining of the aluminum melt to reduce the gas content in the aluminum, minimizing the tendency for gas holes and micro-shrinkage on the surface of the casting.
- (3) Enhance the modification treatment of the casting to further refine the grain size, improving the toughness and crack resistance of the casting material.
- (4) Increase the R corner of the cracking area of the water jacket and optimize the cooling of the bottom mold of the cylinder head to reduce residual stress, among other measures.
