# Enhancing an Automatic Automotive Cable Assembly Line: A Design Science Research Approach to Improve OEE

**Abstract:** The automotive industry demands high standards of efficiency and reliability in order to remain competitive. This study addresses the optimization of an automatic production cell (“Line X”) dedicated to the manufacture of cables for automotive latches, which initially presented critical performance levels, with an average Overall Equipment Effectiveness (OEE) of 42%, significantly below the strategic target of 85%. Adopting the Design Science Research (DSR) methodology, the research diagnosed the root causes of inefficiency, mainly associated with the electric cutting process, cable insertion, and component feed stability. Targeted technical interventions were designed and implemented, including the development of copper-beryllium electrodes with tungsten tips to reduce wear, a new symmetrical electrode opening system to eliminate burrs, and a spiral cleaning tool to prevent insertion failures. The results demonstrated a substantial improvement in operational stability: corrected OEE stabilized above 80%, reaching a peak value of 87.7%, clearly highlighting the

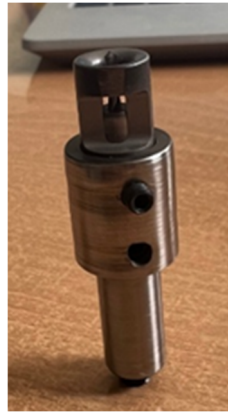
**Figure 4.** View 1 of the created drill.

Figures 4 and 5 illustrate the actual drill bit, already manufactured from the above model. The internal finishing operation of the spiral is then performed at a dedicated station, illustrated in Figure 6. At this station, after the spiral has been cut to the correct length, it is positioned on a support and fixing structure and aligned axially between two drive motors. Two rotary drills are then installed, positioned at opposite ends of the spiral. Each drill is coupled to a servomotor, given the need for precise control of the rotation speed and angular position during the process. These motors are mounted on linear pneumatic cylinders, which allow controlled movement of the drill along the longitudinal axis of the spiral.

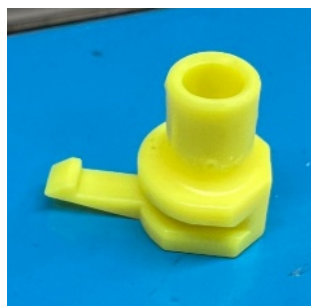
Thus, when inserted, the cable collided with the wall of the spiral, unable to pass through it. This failure caused assembly errors and forced the line to stop, compromising production cadence. In Figure 10, it is possible to see the spiral terminal from another perspective, highlighting the hole where the spiral should fit. Figure 11 illustrates the end of the metal spiral, highlighting its internal hole.

**Figure 10.** Spiral terminal.

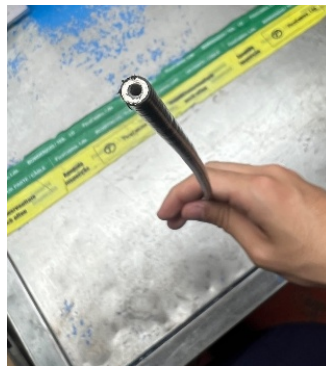
**Figure 11.** Spiral end.

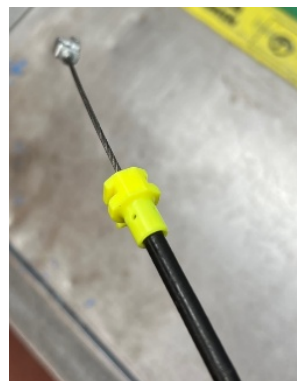
With the intervention made, the terminals now have a tighter hole, allowing for a proper fit of the spiral, with minimal clearance and guaranteed alignment between its internal channel and the cable entry hole. Figure 12 shows a cable already assembled with the terminal and the spiral correctly fixed, demonstrating the success of the intervention.

**Figure 12.** Correctly assembled end cable.

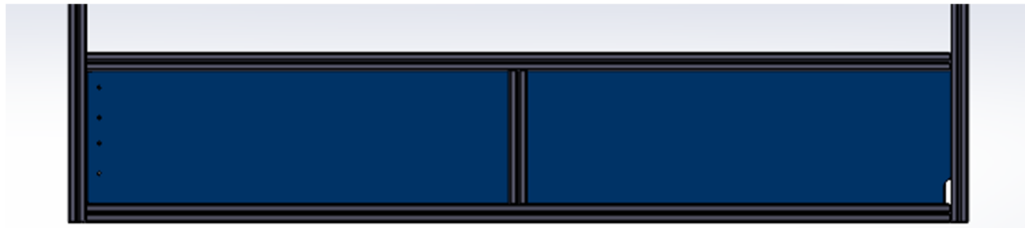
The execution involved cutting the original sheet in half, keeping the left half and replacing the right half with a functional door and a small additional fixed sheet. The holes necessary for the correct fitting and operation of the new door were included, as well as the elements for fixing it to the aluminum structure. The new configuration is illustrated in Figures 20–22, which show the CAD model of the final door, open and closed, as well as the reuse of components.

**Figure 22.** Structure of the rear door of the X Line after intervention.
