# Comparative Investigation on Performance of Fly Ash-Based Geopolymer Paste Subjected to Na<sub>2</sub>SO<sub>4</sub> and MgSO<sub>4</sub> Solution

**How To Cite:** Shi, X.; Long, T.; Zhang, H.; et al. Comparative Investigation on Performance of Fly Ash-Based Geopolymer Paste Subjected to Na<sub>2</sub>SO<sub>4</sub> and MgSO<sub>4</sub> Solution. *Durability and Sustainability* **2026**, *1*(1), 2.

**Abstract:** The present study aimed to evaluate the comparative deterioration mechanism of sulfate solution on the fly ash based geopolymer paste (GP) by soaking in 8% Na<sub>2</sub>SO<sub>4</sub> and 8% MgSO<sub>4</sub> solutions up to 120 days. X-ray CT, SEM, EDS, XRD, FTIR and TGA/DTG were used to characterize the changes in microstructure and products under sulfate attack. Furthermore, the corrosion solution was also analyzed by ICP-OES and pH analysis. The results showed that Na<sub>2</sub>SO<sub>4</sub> and MgSO<sub>4</sub> induced distinctly different deterioration behaviors. After 120 days of immersion, the compressive strength loss rates reached 40.2% and 34.0% in Na<sub>2</sub>SO<sub>4</sub> and MgSO<sub>4</sub> solutions, respectively. Na<sub>2</sub>SO<sub>4</sub> exposu

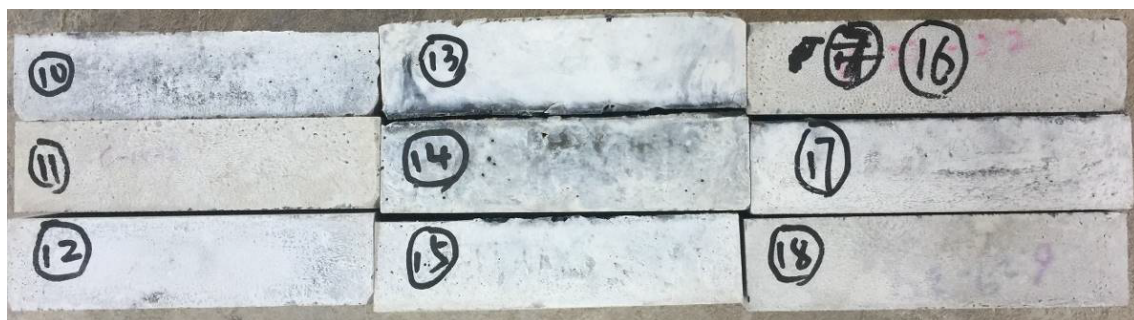
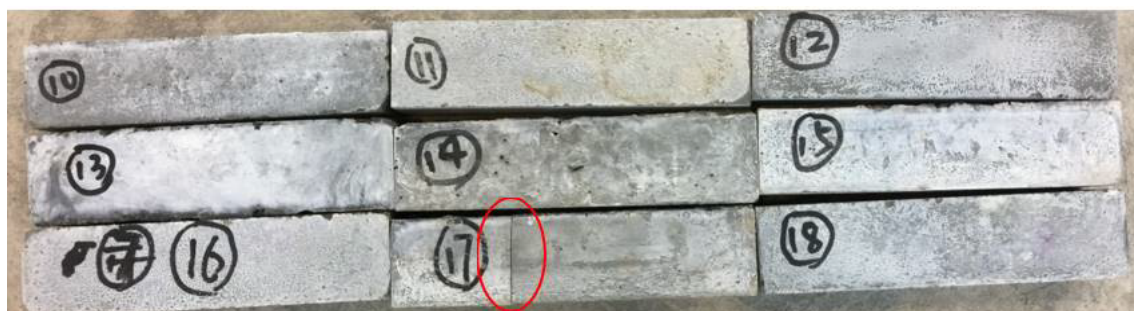
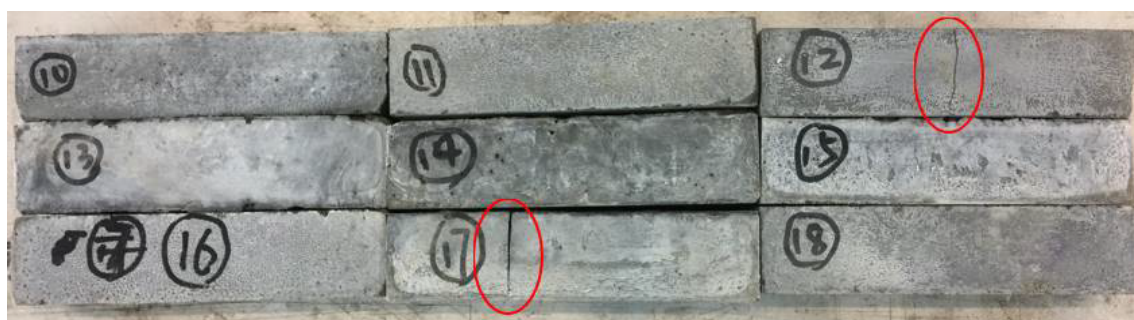
**Figure 4.** The appearance damage of the geopolymer paste before and after  $\text{Na}_2\text{SO}_4$  exposure.

The surface changes of GP specimens before and after exposure to  $\text{Na}_2\text{SO}_4$  solution are presented in Figure 4. Compared with the untreated GP (Figure 4a), powdered and granular  $\text{Na}_2\text{SO}_4$  crystals were observed on the surface of GP after immersion in  $\text{Na}_2\text{SO}_4$  solution (Figure 4d). After 30 days of corrosion with  $\text{Na}_2\text{SO}_4$  solution, specimen No. 17 failed completely (Figure 4b) due to sulfate solution penetration to internal cracks. With prolonged immersion for 60 days, specimens No. 12 also broke (Figure 4c). Furthermore, after 120 days of soaking in  $\text{Na}_2\text{SO}_4$  solution, spalling and fragmentation were observed in three GP specimens (Figure 4d).

The erosion of GP by  $\text{Na}_2\text{SO}_4$  solution and  $\text{MgSO}_4$  solution showed different effects on appearance damage. Comparatively,  $\text{Na}_2\text{SO}_4$  crystals appeared as powdered particles on the surface of GP, while  $\text{MgSO}_4$  crystals were blocky on the surface of the GP. In each group of 9 samples, there are 2 through cracks in the specimens eroded by  $\text{Na}_2\text{SO}_4$  solution, while 5 through cracks in the specimens eroded by  $\text{MgSO}_4$  solution. The  $\text{MgSO}_4$  solution erosion resulted in more through cracks in the GP specimens. In addition, it can be concluded that  $\text{Na}_2\text{SO}_4$  solution erosion makes GP flake, while  $\text{MgSO}_4$  solution erosion hardly makes GP flake. These appearance damage phenomena confirm that the erosion of  $\text{MgSO}_4$  solution makes it easier to connect the pores in the GP, resulting in the formation of more through cracks. Moreover, the erosion mechanisms of  $\text{Na}_2\text{SO}_4$  and  $\text{MgSO}_4$  on GP are inconsistent, and the differences of erosion mechanism were analyzed in the subsequent microscopic analysis.

(1) Exposure to Na<sub>2</sub>SO<sub>4</sub> and MgSO<sub>4</sub> solutions resulted in distinct deterioration patterns in GP specimens. As directly observed, Na<sub>2</sub>SO<sub>4</sub> exposure mainly caused surface exfoliation, whereas MgSO<sub>4</sub> exposure induced more pronounced through-thickness cracking.

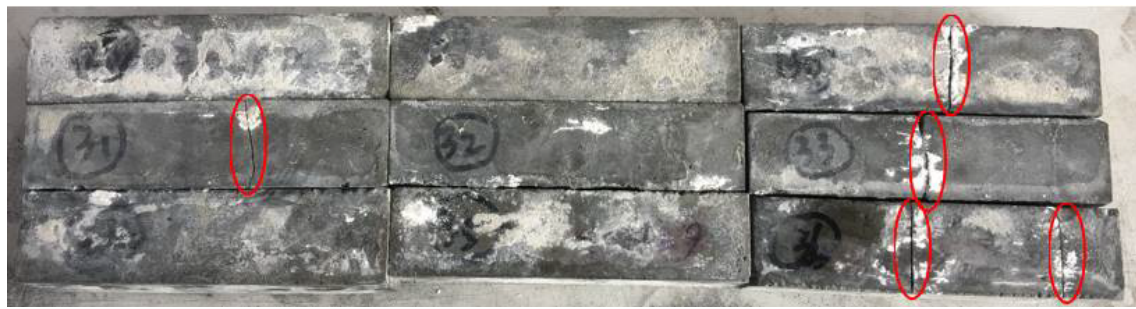
**Figure 5.** The appearance damage of the geopolymer paste before and after  $\text{MgSO}_4$  exposure.

The surface changes of GP specimens before and after exposure to  $\text{MgSO}_4$  solution are presented in Figure 5. Compared with the GP before exposure to  $\text{MgSO}_4$  solution (Figure 5a), massive  $\text{MgSO}_4$  crystals formed on the surface of GP after  $\text{MgSO}_4$  solution erosion, with almost no spalling fragments observed. After 30 days of exposure to  $\text{MgSO}_4$  solution, two specimens (No. 30 and No. 36) were broken into two segments due to through crack, and  $\text{MgSO}_4$  crystals were concentrated along the cracks (Figure 5b). After being eroded by  $\text{MgSO}_4$  solution for 60 days, the specimen No. 36 was broken into three sections due to the penetration of the solution to the two cracks. The specimen No. 33 also fractured at the place where  $\text{MgSO}_4$  crystals were enriched (Figure 5c). After 120 days of  $\text{MgSO}_4$  solution corrosion, the specimen No. 31 was also broken into two segments due to through cracks (Figure 5d).
